# Manhole Inspection Summary

Manhole # S41E\_\_028MH

**Inspection** ☐ Is Incomplete Rating: **5) Immediate Attention Required**

**Location** Address: **e lombard st**

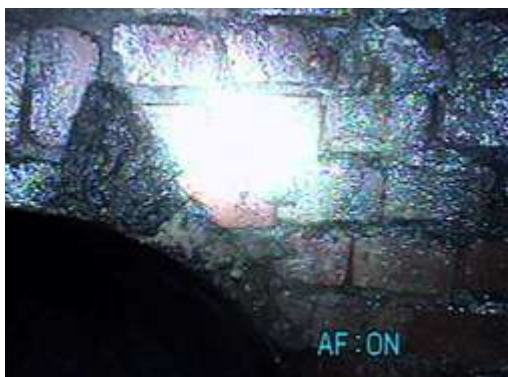
Defect 3

**Barrel** Material: **Brick** ☐ Parged

Infiltration: ☐ None ☐ Joint ☐ Cracks ☐ Mortar ☐ Roots ☒ **Wall**

barrel infiltration at wall

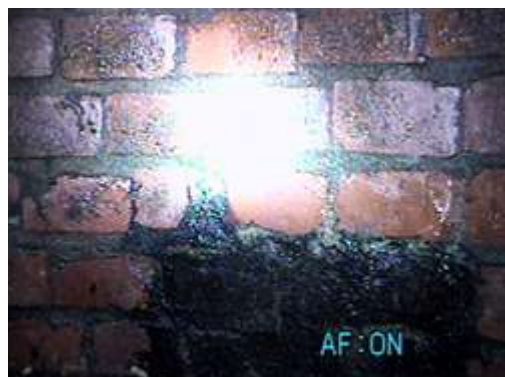
Defect 2

**Corbel** Material: **Brick** ☐ Parged Type: **Concentric/Eccentric**

Infiltration: ☐ None ☐ Joint ☐ Cracks ☐ Mortar ☐ Roots ☒ **Wall**

corbel infiltration at wall

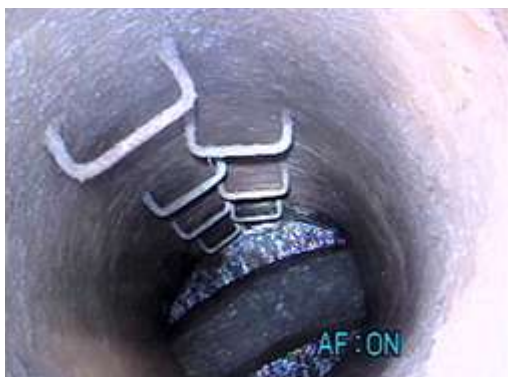
Defect 1

**Steps** Count: **8** Missing: **0** ☒ **Corroded**

steps corroded

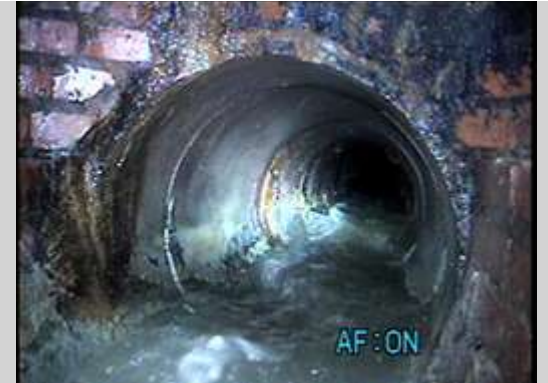
12 O'Clock Outflow

27 in. Circular Gravity Sewer  
Pipe Out @ 12 O'Clock

Pipe Material: **Clay** ☐ Pipe Lined

Invert Depth: **13.58** (ft.) Flow Characteristics: **Fast**

Infiltration: **None** Pipe Seal Cond: **Unknown**

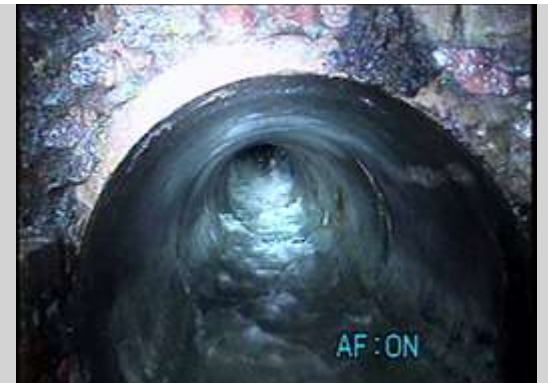
5 O'Clock Inflow

27 in. Circular Gravity Sewer  
Pipe In @ 5 O'Clock

Pipe Material: **Clay** ☐ Pipe Lined

Invert Depth: **13.50** (ft.) Flow Characteristics: **Fast**

Infiltration: **None** Pipe Seal Cond: **Unknown**
